Excavations at the Castillo de San Marcos  
St. Augustine, Florida:  
Archeological Data in Support  
of Architectural Stabilization

Kathleen Deagan  
Florida State University  
December 1980

Submitted to: The National Park Service Southeast Archeological  
Center  
Tallahassee, Florida  
NPS-FSU Contract #50 0090739

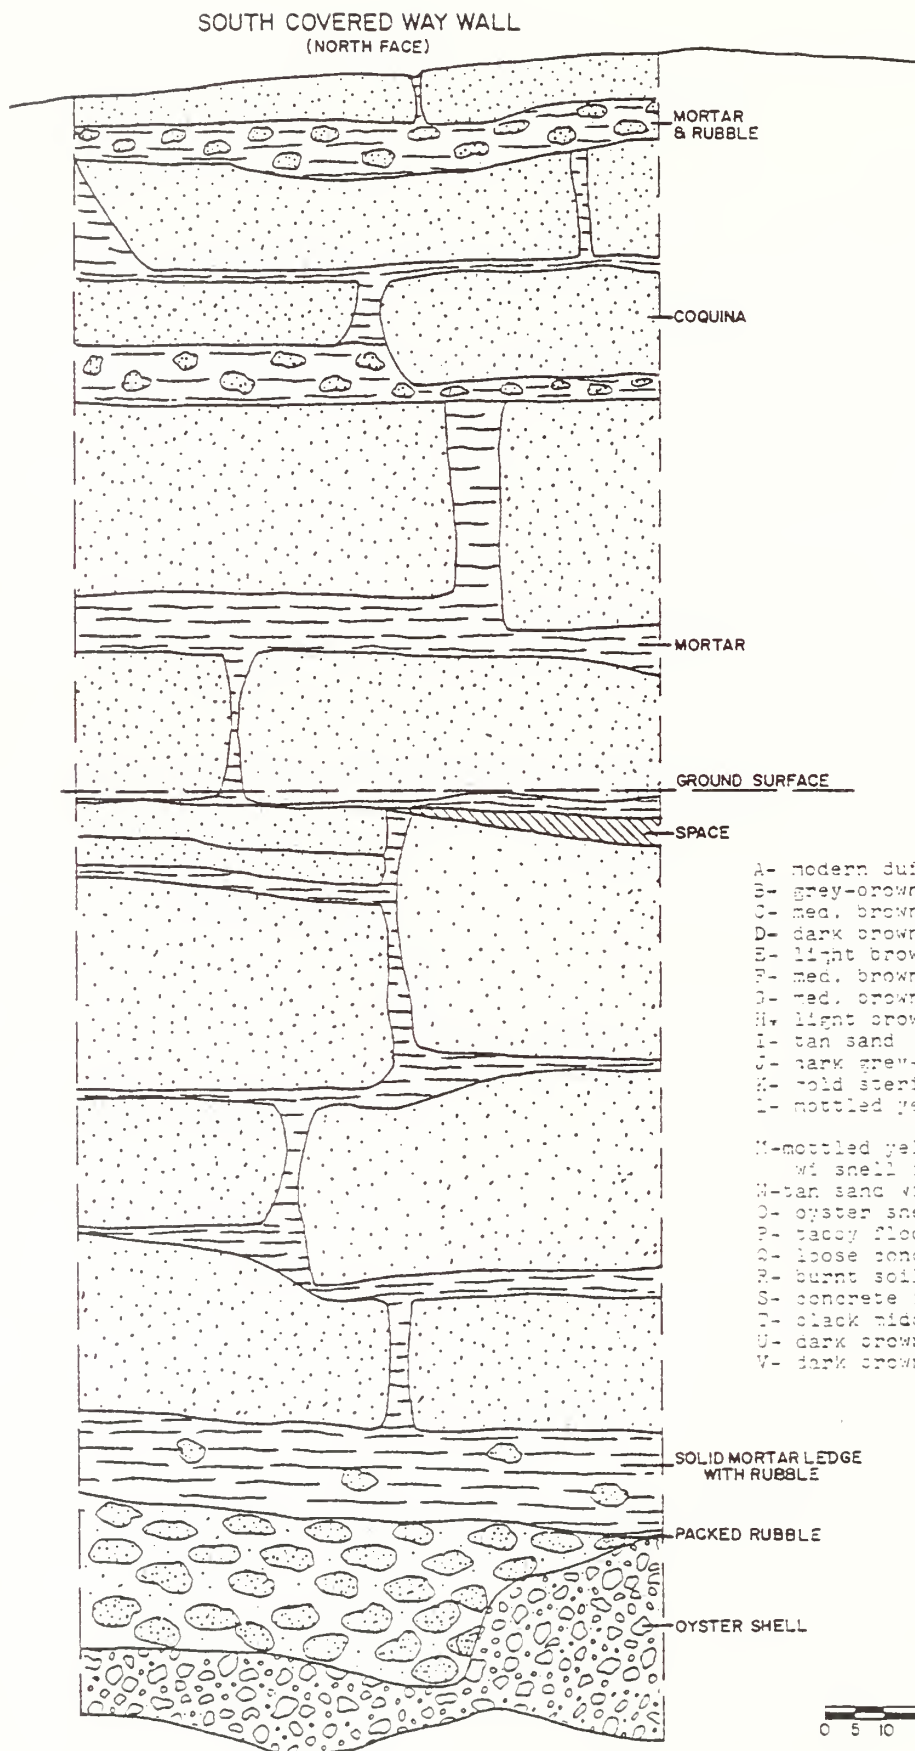
The base of Zone F appeared in level 8 (3.11 MMSL to 2.98 MMSL) at 3.00 MMSL. At this point areas of yellow and brown mottled soil with crushed shells were apparent, which upon excavation, were revealed as a zone of soil disturbed by the initial construction of the south covered way wall. This appears in Figure 3 as Areas "E", "B", and "M". Its nature became apparent with the appearance of the oyster shell footing which occurred below these areas, near the base of level 8, at 2.98 MMSL. This footing was of packed whole and crushed oyster shells, as well as packed building rubble, and apparently was packed into a footing trench approximately 35 cm. deep. No evidence for a builders trench was found. Level 9 was adjacent to the footing itself, and was excavated from 2.93 MMSL to 2.78 MMSL. The fill of level 9 was the

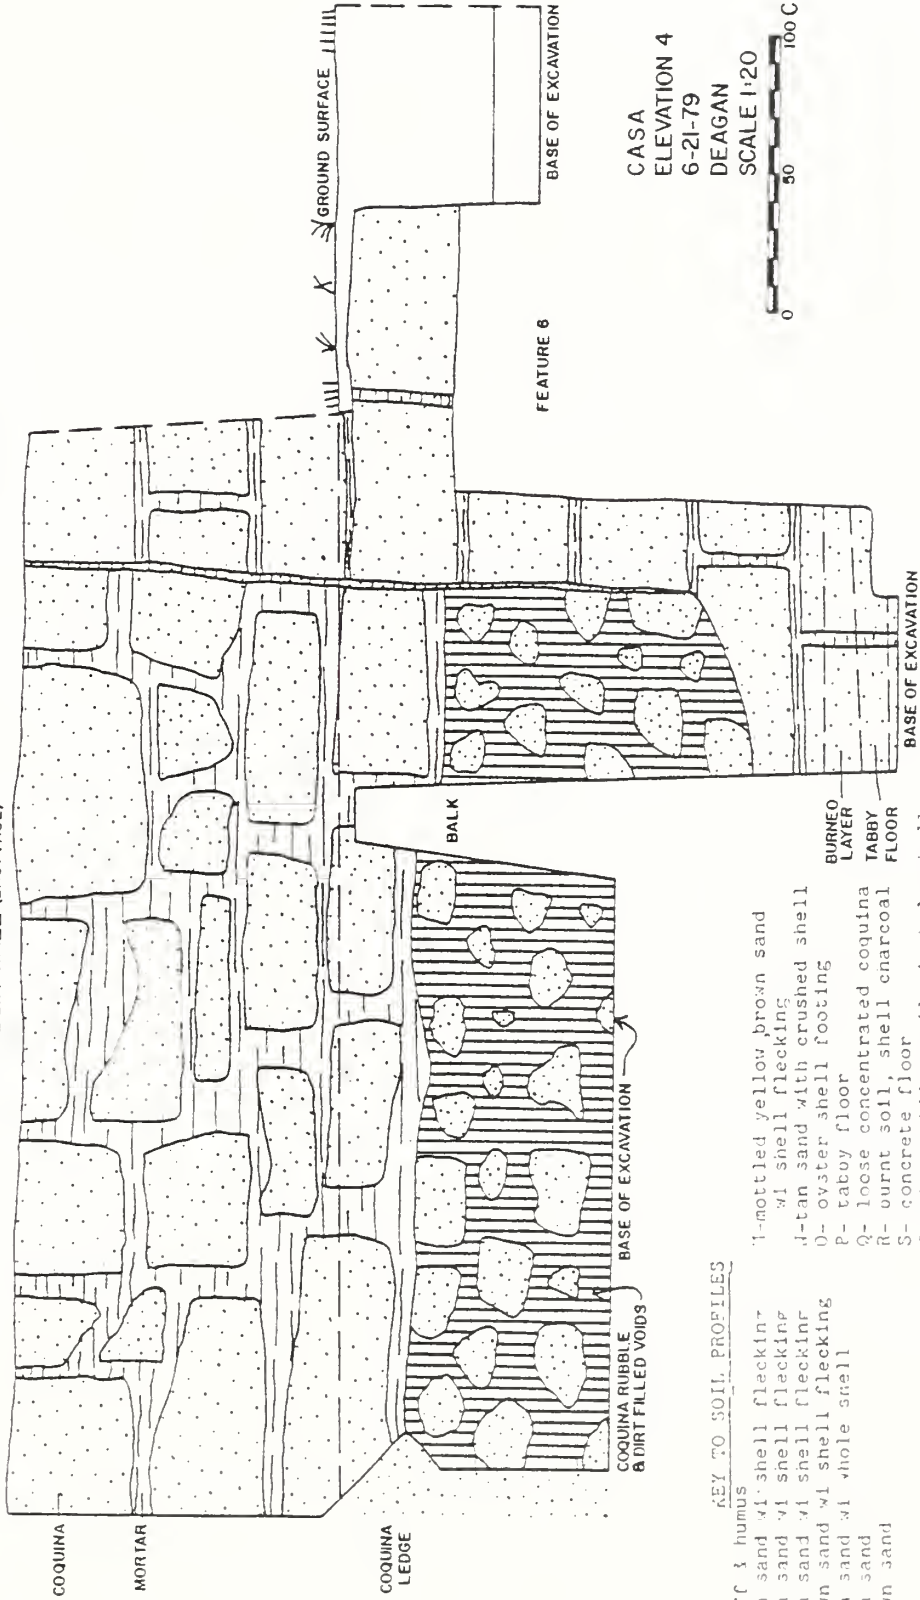
CASA  
ELEVATION 4  
6-21-79  
DEAGAN  
SCALE 1:20

RAVELIN WALL (EAST FACE)

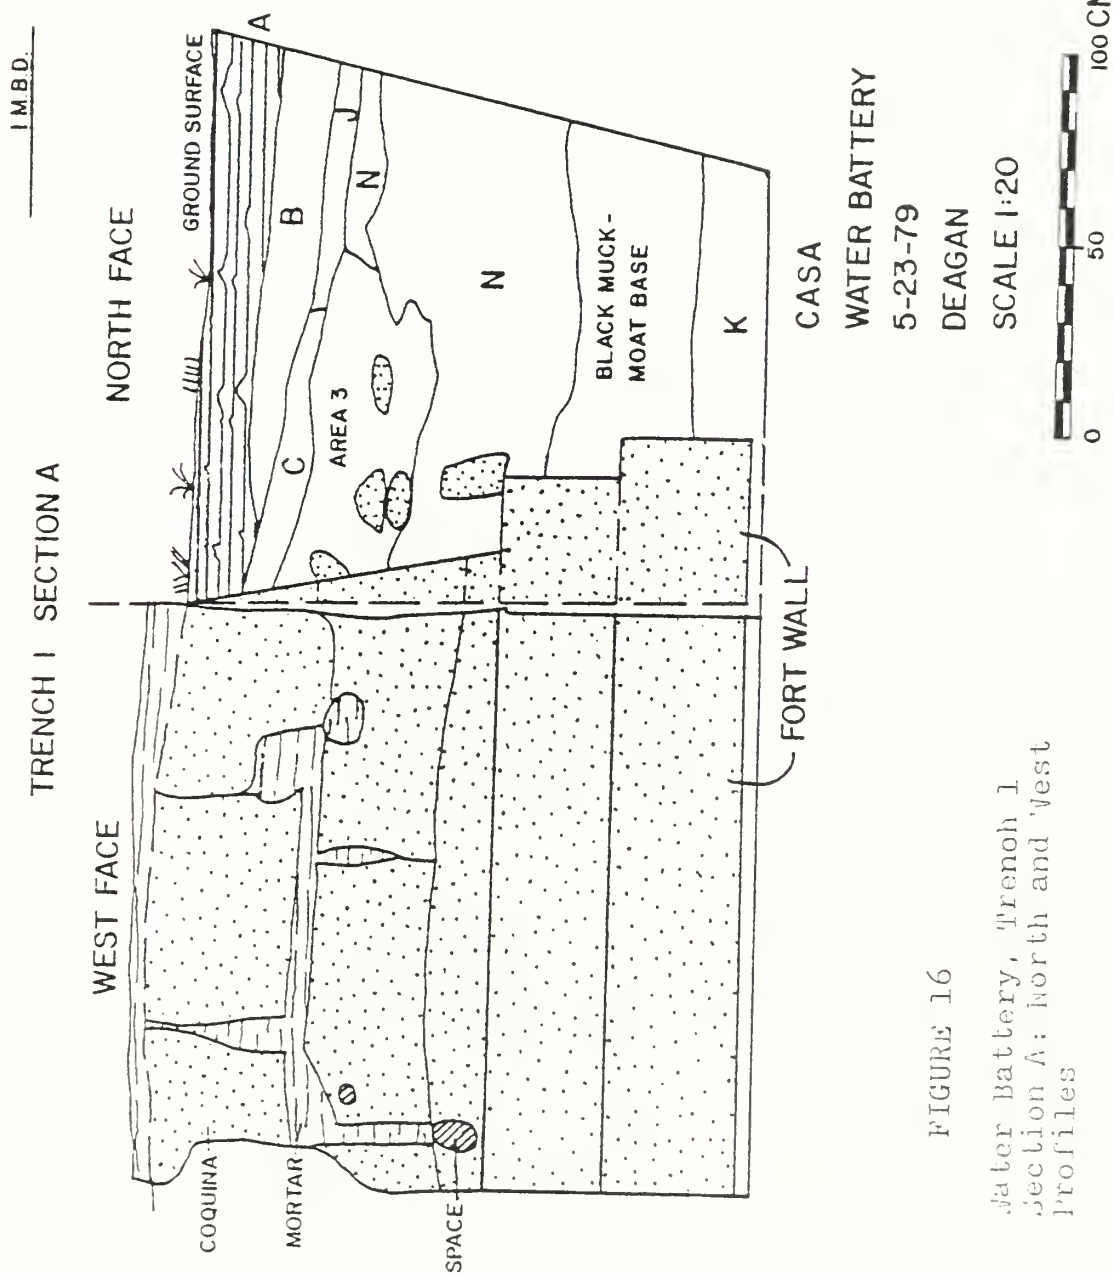
FIGURE 16

Water Battery, Trench 1  
Section A: North and West  
Profiles

Figures 16 and 17, and Tables 16 and 17 show the stratigraphic situation and artifact distributions adjacent to the fort's exterior east scarp face. Ground surface in this area is at 2.33 MMSL. The old moat surface (Zone 6) was encountered at 1.41 MMSL, or 92 cm. below present ground surface. This was a layer of black muck and mud, 30 cm. thick, and resting on yellow-white sterile sand. This old moat base layer contained artifacts dating exclusively to the first Spanish period, suggesting that the moat was cleaned out shortly before the water battery was filled in. The base of the moat corresponds almost exactly to the 1940 moat base indicated by Manucy (1940). The 1940 base was 4 inches below the top of the lower course (toe) of the fort foundation, and the water battery old moat base was 4.5 inches below the top of the lower course (toe) of the fort foundation in the water battery (Manucy's investigation was in the south moat).

The layers in Figure 16 designated C, J, and N are of dark grey-brown soil and probably represent an earlier (19th century) ground surface. Thus the filled grade for the water battery was about 2.02 MMSL, or 30 cm. below present surface. Between this surface and the black moat muck is tan beach sand filled with shells. All material from these layers date post-1790, and all material above the suggested 19th grade dates to modern (post-plastic) times.

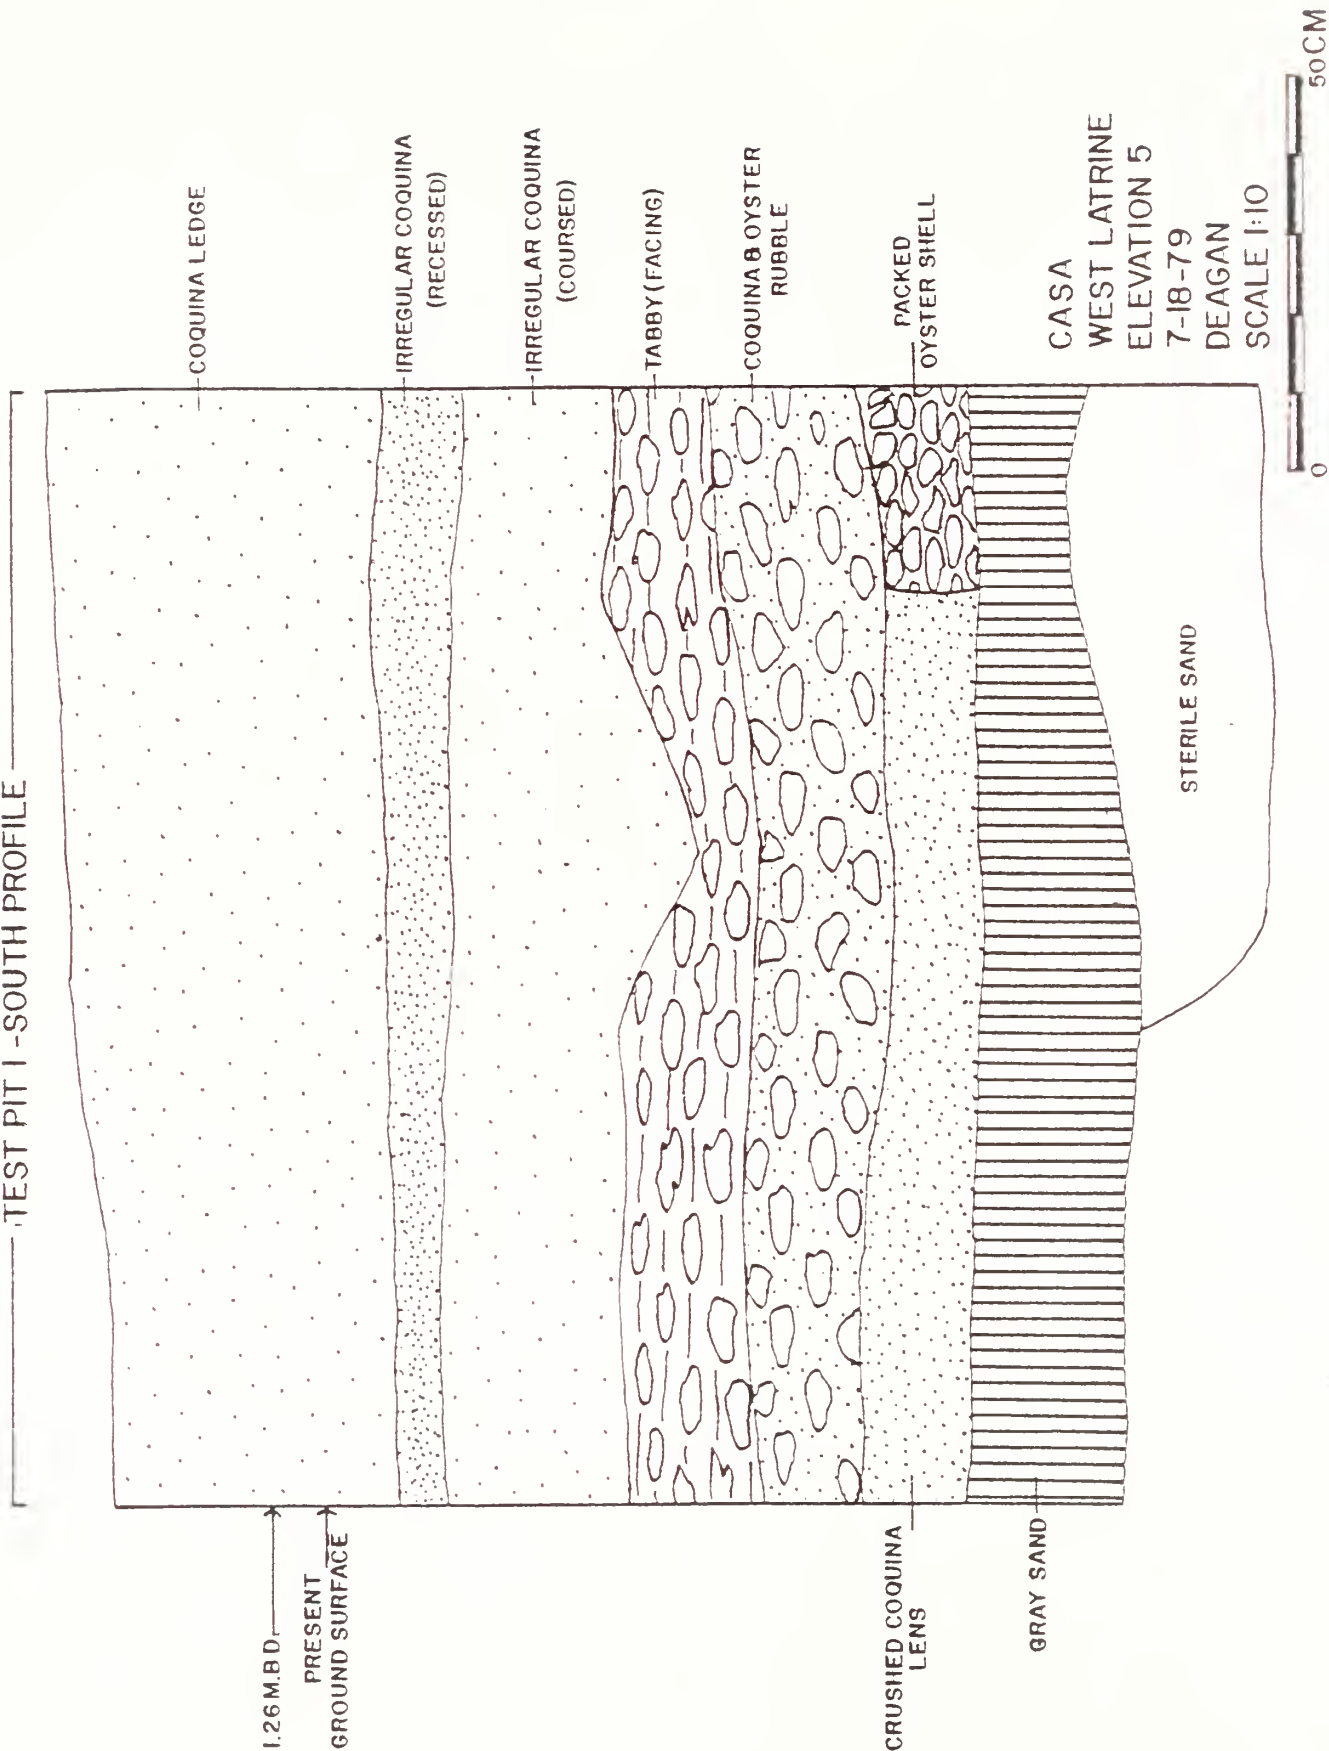
FIGURE 22

West latrine, Test Pit 1  
South profile

At 3.26 MMSL (ca. 40 cm. below the ledge top, and 15 cm. above Floor 3) a recess, 8-10 cm. wide, filled with irregular chunks of coquina, is present. Above that level a solid slab of coquina, partially faced with mortar and plaster, constitutes the upper stage of Feature 14. Below the recess, the feature is comprised of irregularly coursed coquina masonry, extending 35 cm. to rest on a packed footing of coquina chunks and oyster shell (Fig. 22).

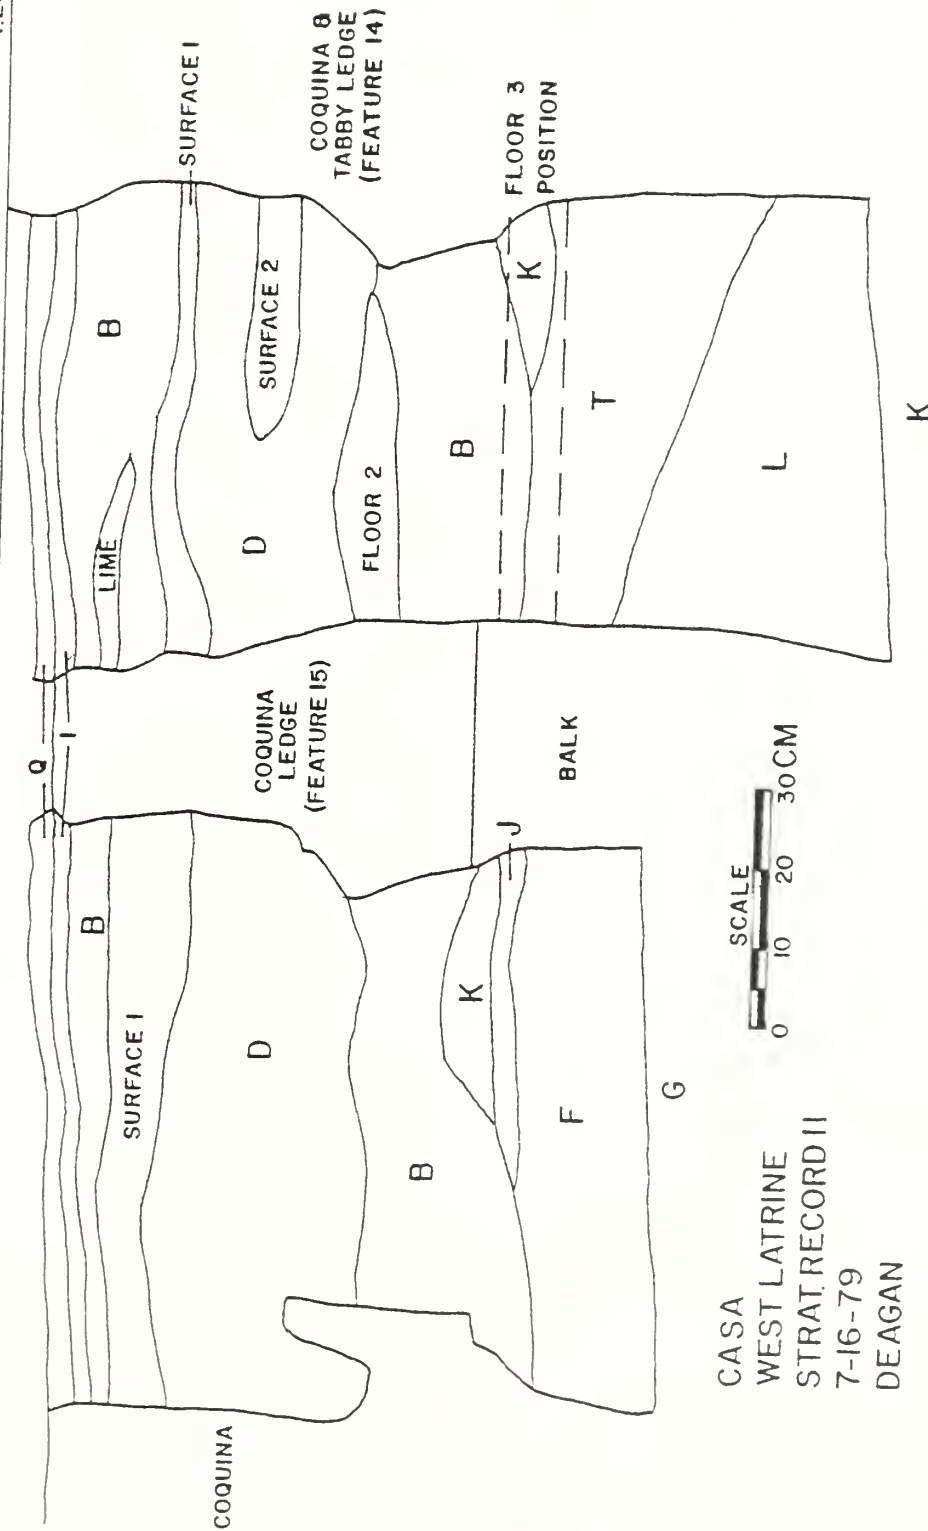
FIGURE 23.

West Latrine, Test Pit I  
East Profile

Floors 2 and 3 coorespond almost exactly to the elevations of those floors in the east latrine. Floor 3 was partially removed by the construction of Feature 15, and thus does not appear in the east profile (Fig. 23) since it remained only in the west end of the unit.

Floor 3 lies directly above the aboriginal midden layer discussed above; and represented by layer "T" in Figure 23 (this was encountered only outside of Feature 15). The aboriginal component was excavated as Zones 7-9. The floor (also appearing in other parts of the unit as Zone 6, is almost certainly the earliest floor in the room. At the place in time represented by Floor 3 (minimally 1750-1763); the coquina banquette or ledge on the south side of the latrine (Feature 14, Figs. 25, 27) most likely contained the three privy holes represented on the 1763 map. Figure 25, showing the south face of the ledge, suggests that it may have been made in at least two phases.

However, if the interpretation of the privy holes and Floor 3 given above is valid, the Floor 2 and the associated Feature 15 must date to after 1763 (when the privy holes still appear on the map). Thus at some time after 1763, the layer of earth constituting Zones 4-5 (lower layer "B", Fig. 23) was deposited, raising the floor level to that of Floor B and providing support for the lower 15 cm. of Feature 15's walls.

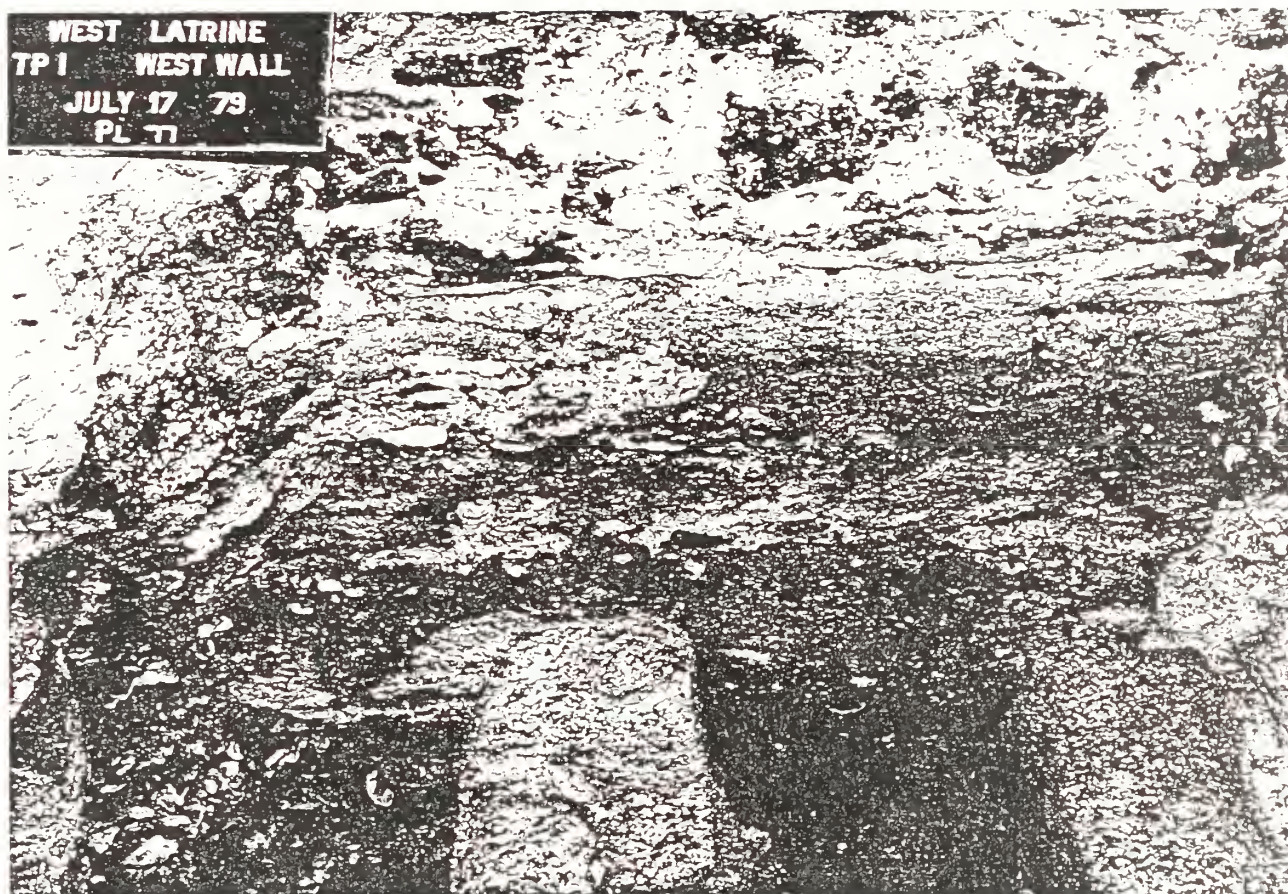
FIGURE 25

West latrine, Test Pit 1, West Elevation

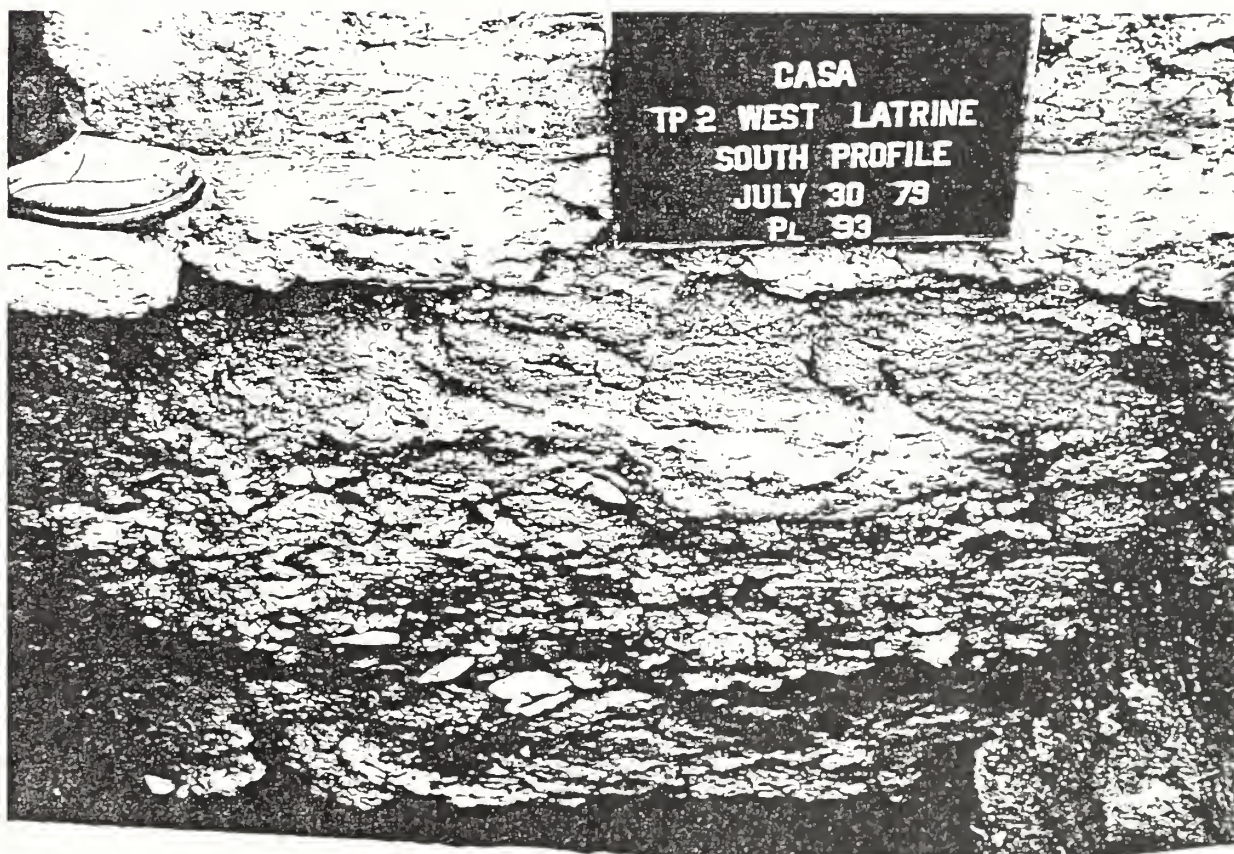
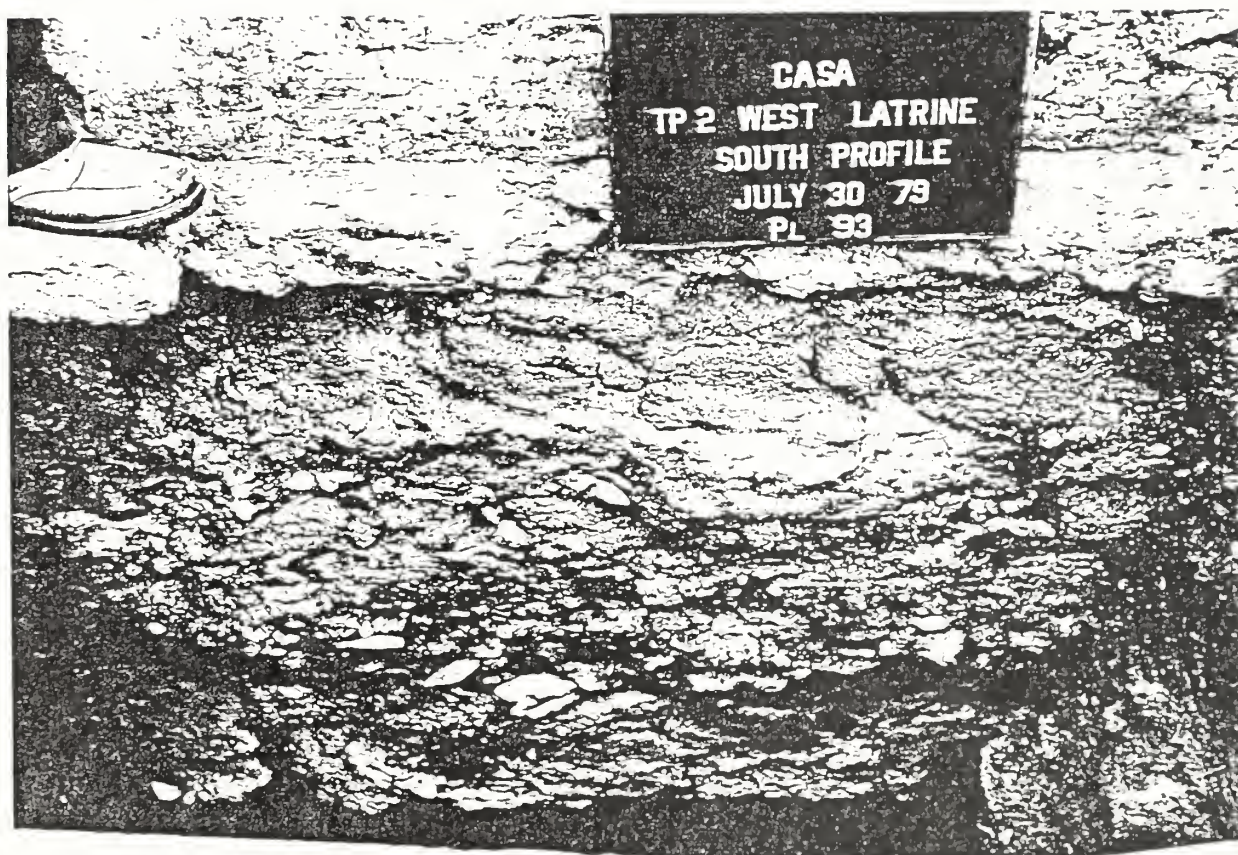
FIGURE 29

time after the establishment of Feature 18 (post-1795), in order to effect repairs to the ramp wall. This is further supported by the presence of alternating layers of coquina rubble and grey cement extending in the ramp wall from the top of the construction pit to the base of the wall (Fig. 29). The ramp is known to have been repaired in 1885 (Luis Arana, personal communication, St. Augustine 1980), and this repair is highly likely to have resulted in Areas 1-3, and the ramp wall configuration. It was also during this time that the circular hole discussed above was most likely to have been filled in.

est Latrine (Courtyard Pit), Test pit 2  
South Elevation

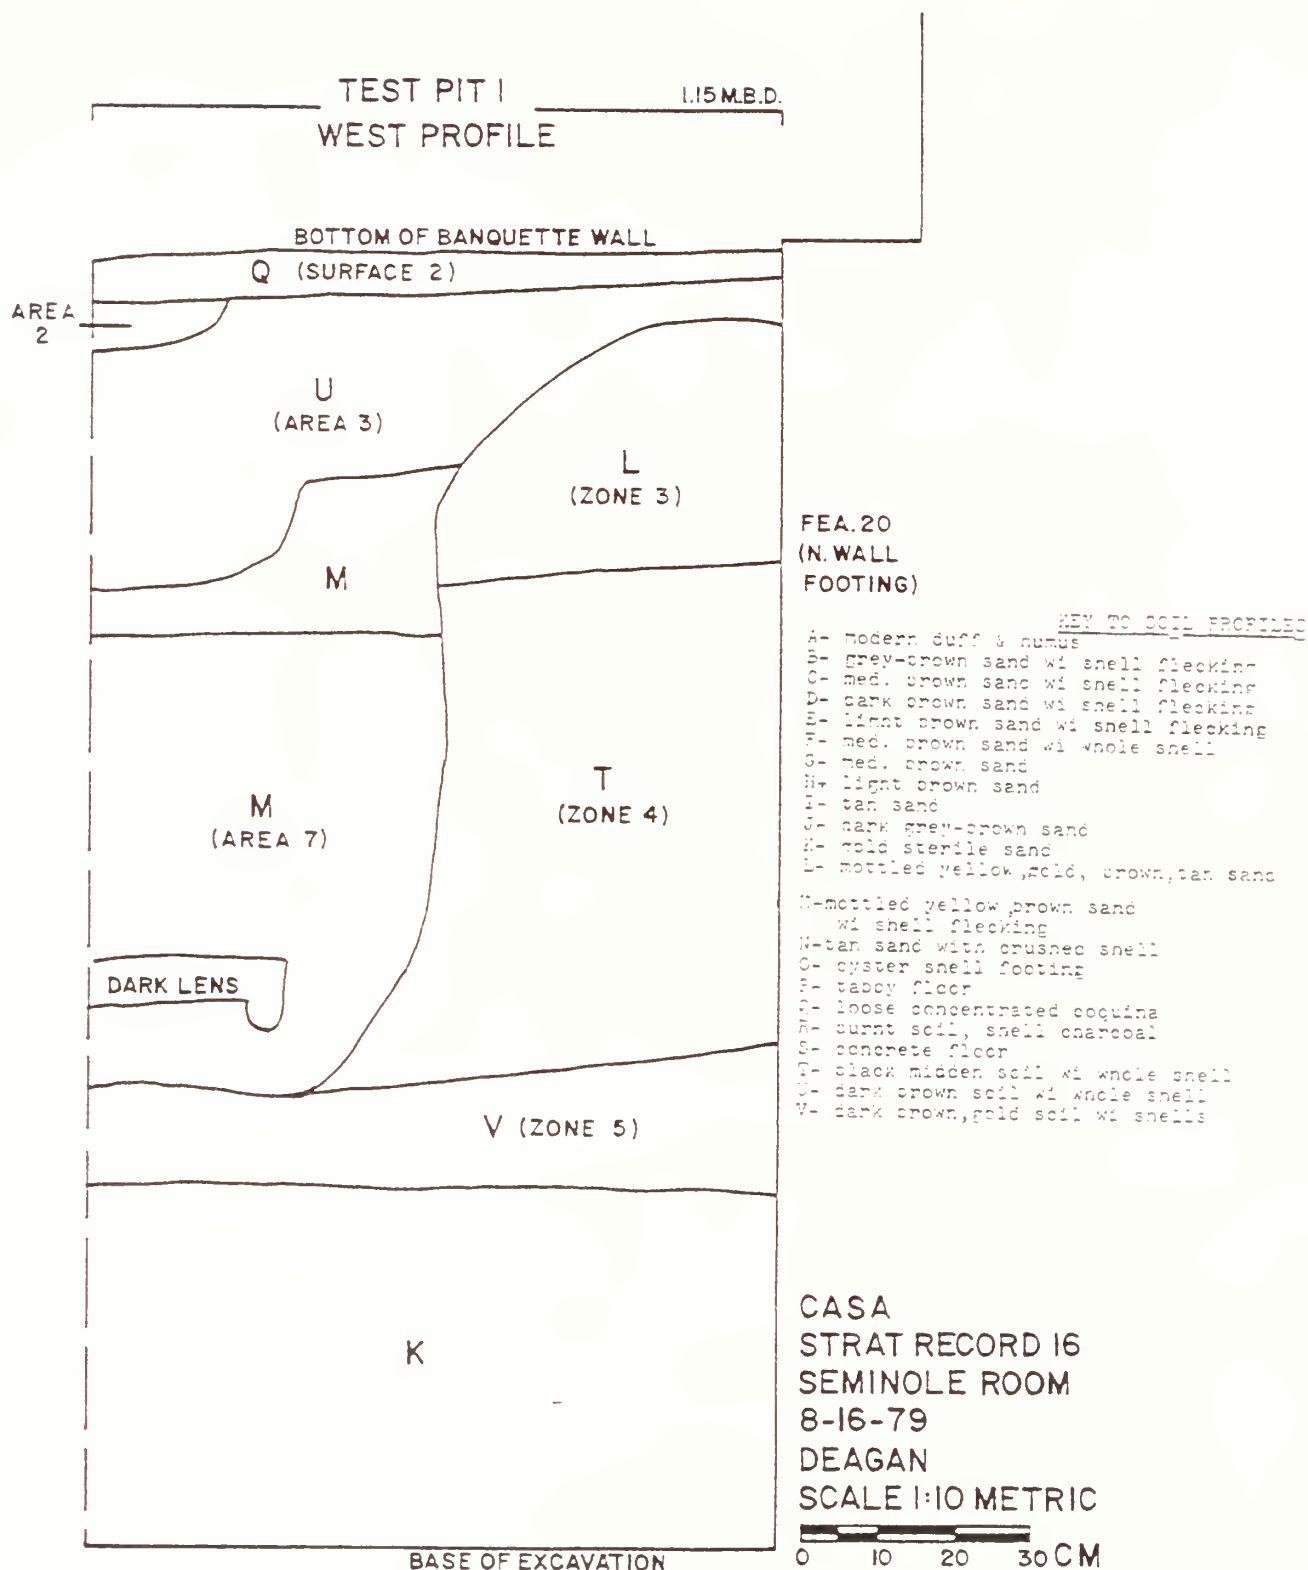
FIGURE 32

The archeological evidence suggests that the 1675 Salazar map was quite accurate. The west profile of Test Trench 1 shows an abrupt and deep discontinuity at precisely the location expected, if indeed the pit cut across the moat's east-west jog (Figure 32). In this figure, "T" is dark midden soil containing whole shells, which was excavated as Zone 4, and which appears to have been a primary deposit. This was possibly the ground surface prior to the Castillo's construction. The top elevation of this zone, at 2.87 MMSL, is only 10 cm. higher than the top of the same zone in the latrine excavation units. Only aboriginal materials were recovered from this zone.

The areas designated on Figure 32 as M, L and U are believed to have been the fill added to the area between 1675 and 1685. Excavated respectively as Area 7, Zone 3 and Area 3, they contained no dateable material. Unlike Zone 4 (T), however, the presence of olive jar fragments, unglazed, wheel thrown coarse earthenwares, iron flakes and a chip of red brick or tile indicates that these deposits were made during the historic period.

Seminole Room, Test Pit 1, West Profile
